UNITED STATES
DEPARTMENT OF LABOR
MINE SAFETY AND HEALTH ADMINISTRATION
METAL AND NONMETAL MINE SAFETY AND HEALTH
REPORT OF INVESTIGATION

Fatal Machinery Accident
November 6, 2005

Empire Mine
Empire Iron Mining Partnership
Palmer, Marquette County, Michigan
Mine I.D. No. 20-01012

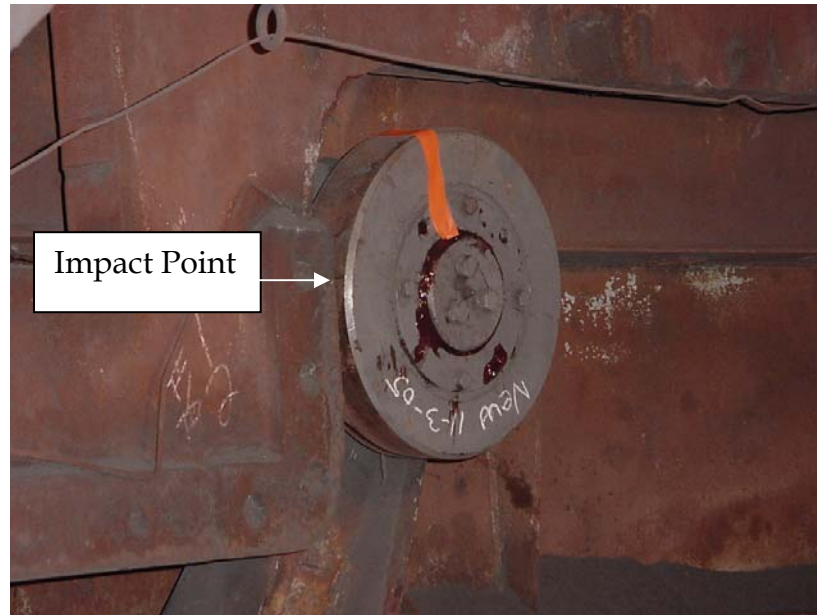
Picture #5

A walkway was provided along the inner diameter of the cooler. The outside edge of the walkway had a solid handrail in place to prevent persons from contacting the slow moving dump arms and wheels. A pull cord was positioned around the cooler circumference and near the moving wheels to stop the cooler if pulled. At the location of the stuck cooler pallet tripper arm, an approximately 98-inch wide opening existed in the solid handrailing with two removable chains provided. The upper chain was 29-½ inches from the floor and the lower chain was 14-½ inches from the floor. These chains were permanently attached at one end and slipped onto a hook positioned at the opposite end (see picture #5). When these chains were removed, access was provided to free the stuck cooler pallet dump arm.
